MSC-PA-R-68-7
Supplement 3-

APOLLO 5 MISSION REPORT
COMMUNICATIONS SYSTEM PERFORMANCE

APOLLO 5 MISSION REPORT

COMMUNICATIONS SYSTEM PERFORMANCE

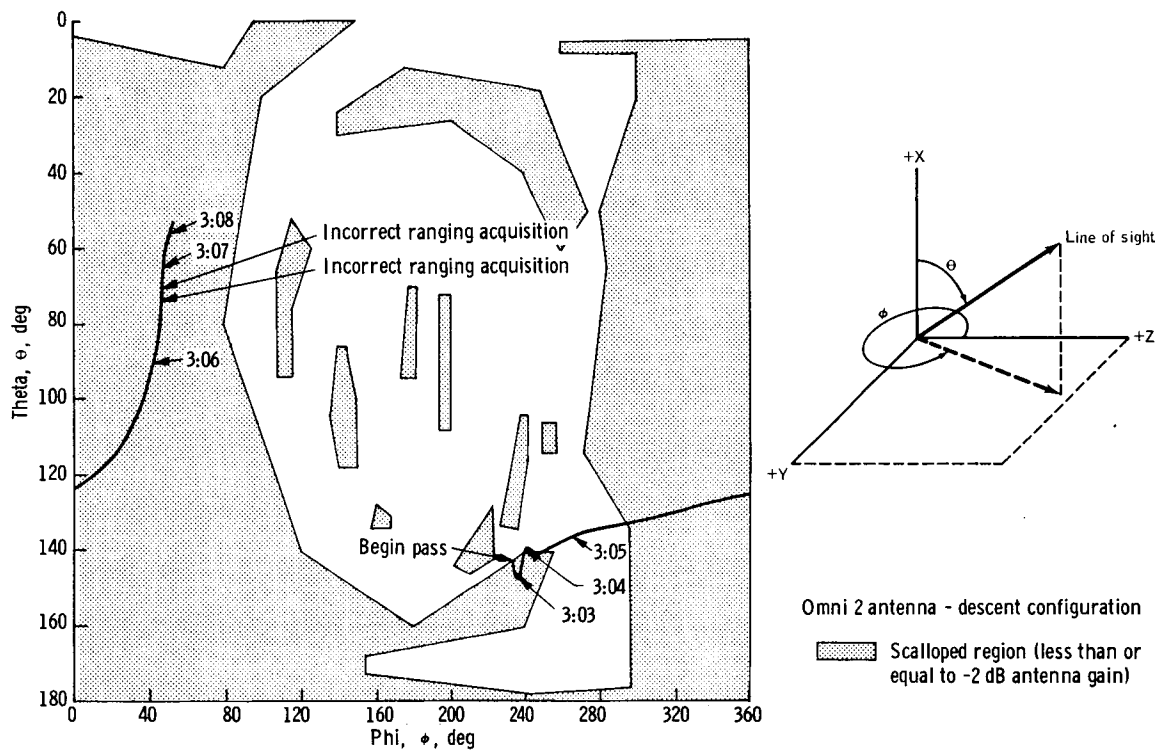
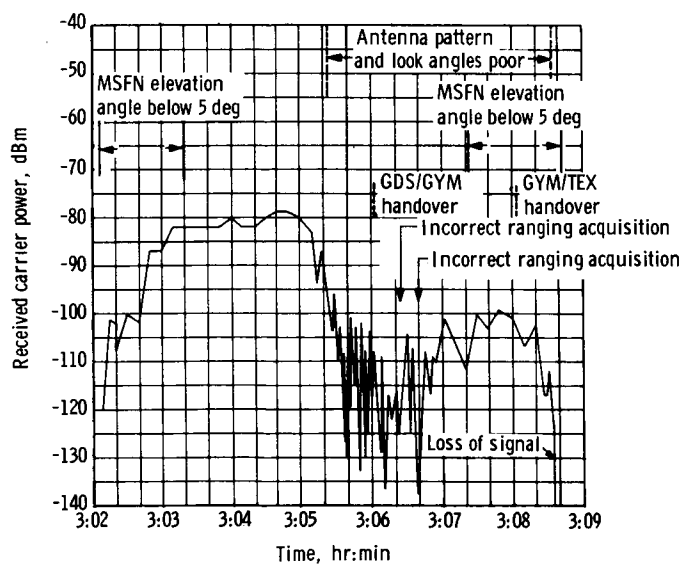
Figure 1. - Received S-band downlink carrier power and look angles, Guaymas, revolution 2.

Station	Revolution	Time, hr:min:sec	Figure number	Comments
Guaymas	2	3:06:28	1	Incorrect acquisition attributed to rapid signal level variations causing sharp correlation voltage variations during acquisition. The spacecraft-to-site look angle was in the scalloped (unfavorable) region of the omni 2 antenna pattern. The omni 1 antenna would have provided approximately 25 dB stronger carrier power than omni 2.

3:06:40	1	Incorrect acquisition attributed to rapid signal level variation. The spacecraft-to-site look angle was in the scalloped region of the omni 2 antenna pattern. The omni 1 antenna would have provided approximately 23 dB stronger carrier power.
Texas	3	4:41:28	2	Incorrect acquisition resulted from rapid signal level variation. The spacecraft-to-site look angle was in the scalloped region of the omni 2 antenna pattern. The omni 1 antenna would have provided approximately 17 dB stronger carrier power.
Ascension	5	6:40:52	3	Incorrect acquisition resulted from rapid signal level variation. This acquisition was attempted during antenna keyhole when the downlink received carrier power was less than minus 140 dBm. Antenna patterns at 6:40:52 indicate that had the Ascension antenna not been tracking through the keyhole, the downlink received carrier power would have been greater than minus 90 dBm and a ranging attempt would probably have been successful.

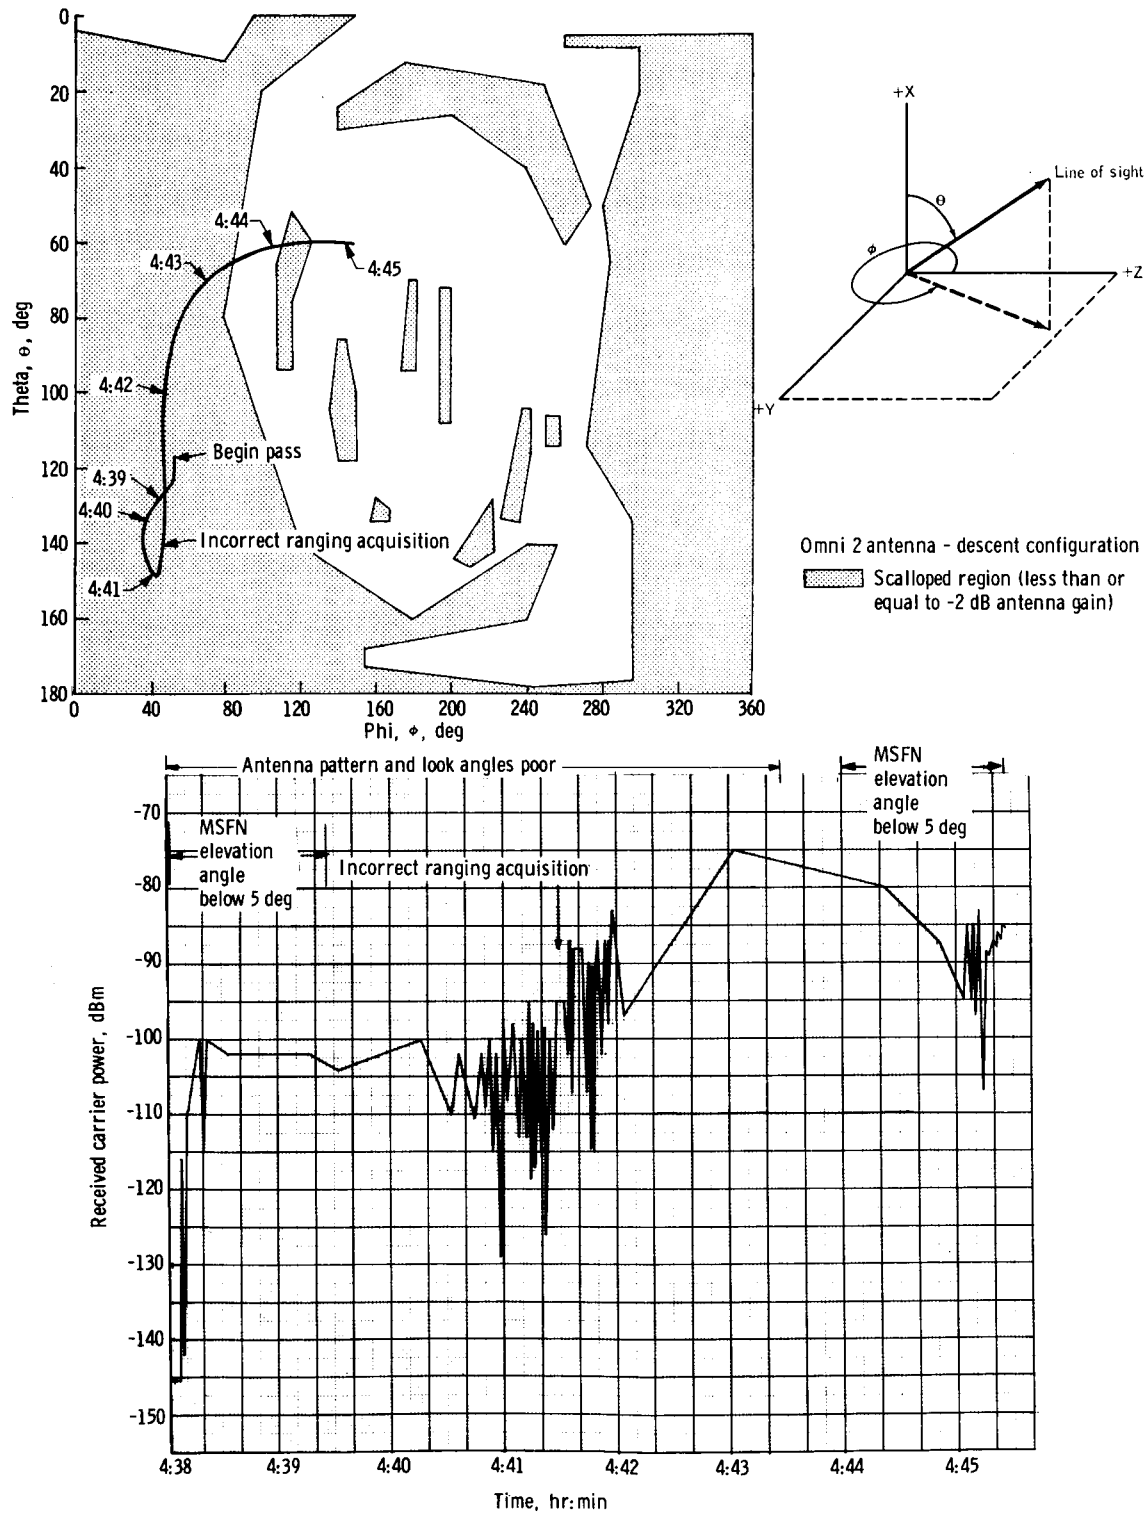
Figure 2. - Received S-band downlink carrier power and look angles, Texas, revolution 3.

The incorrect range code acquisition at 4:41:28 (Texas site, revolution 3) has been selected to show that antenna switching from omni 2 to omni 1 would have provided favorable communications coverage. Figure 6 shows a comparison of the gains of the active (omni 2) and inactive (omni 1) antennas. The omni 2 gain was weak and rapidly varying at the time of the ranging acquisition attempt, whereas the inactive antenna gain would have been consistently higher, resulting in better communications coverage. Figure 7 is a typical example of the relative gains of omni 1 and omni 2 antennas. This figure shows overlapping coverage, which allows for switching time, and indicates that a combination of both antennas would have provided 360-degree coverage in the plane with theta of 90 degrees.

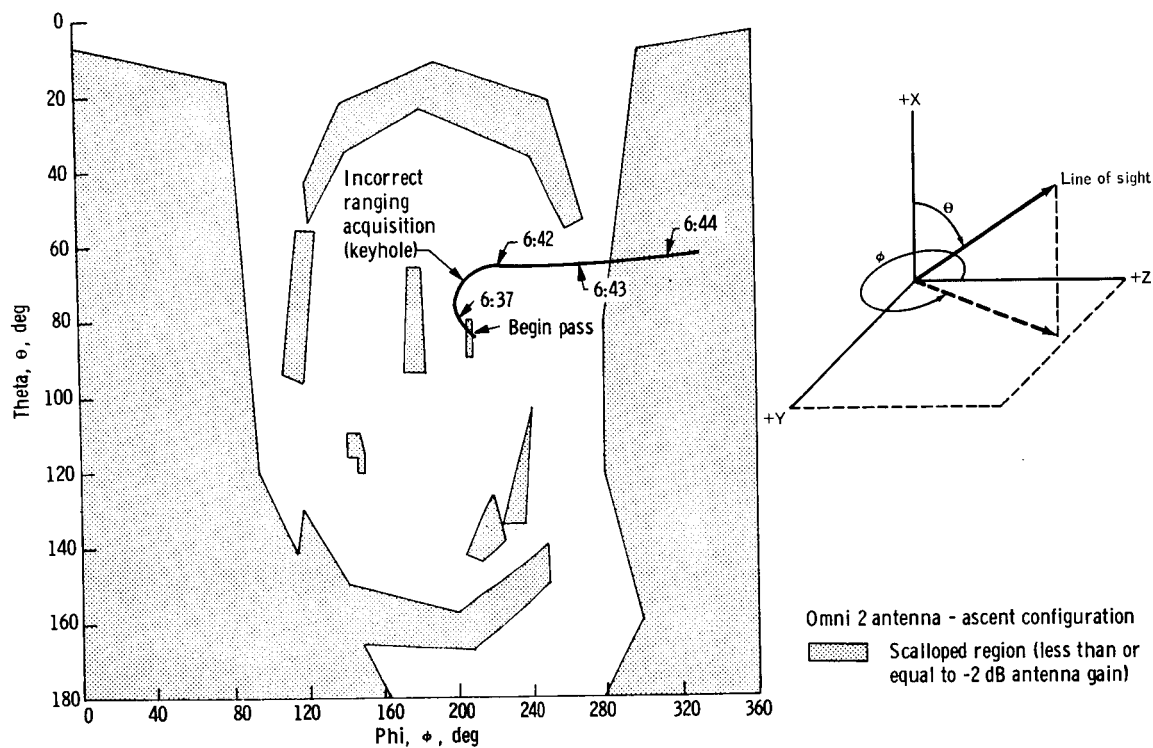
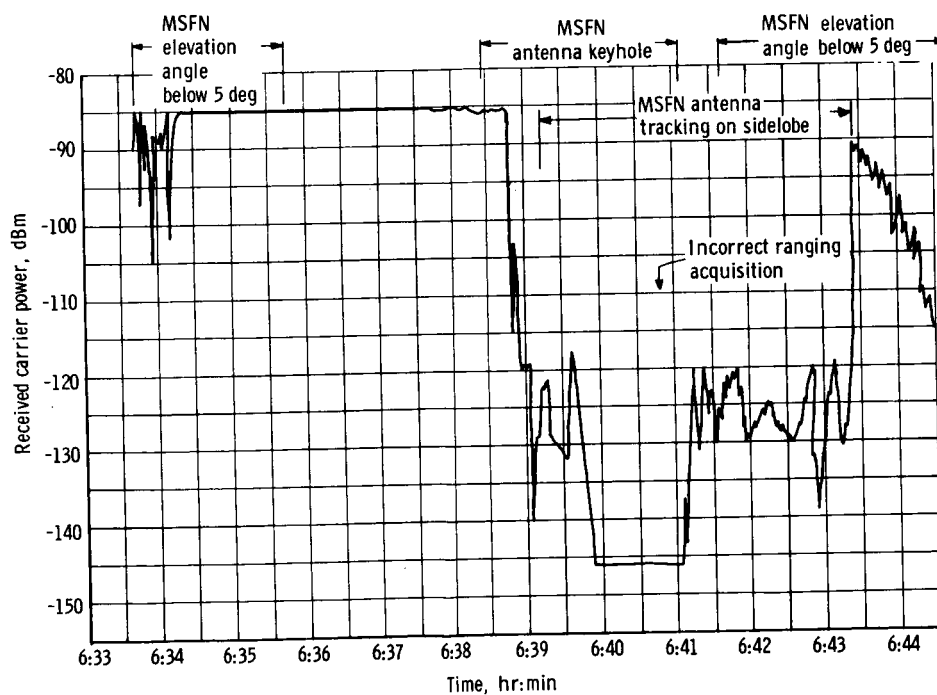
Figure 3.- Received S-band downlink carrier power and look angles, Ascension, revolution 5.

Figures 1 through 5 and table I show that all but one of the incorrect acquisitions (the one at the Ascension site during revolution 5 at 6:40:52) occurred when the look angles between the spacecraft and MSFN site were within the unfavorable region of the antenna pattern, thus resulting in weak received signals. However, could the omni 2 antenna

have been selected, the downlink received carrier power would have been improved by 17 to 26 dB. The only incorrect ranging acquisition during favorable antenna coverage was caused by an attempt to achieve a range acquisition during a site antenna keyhole when the downlink received carrier power was less than minus 140 dBm.

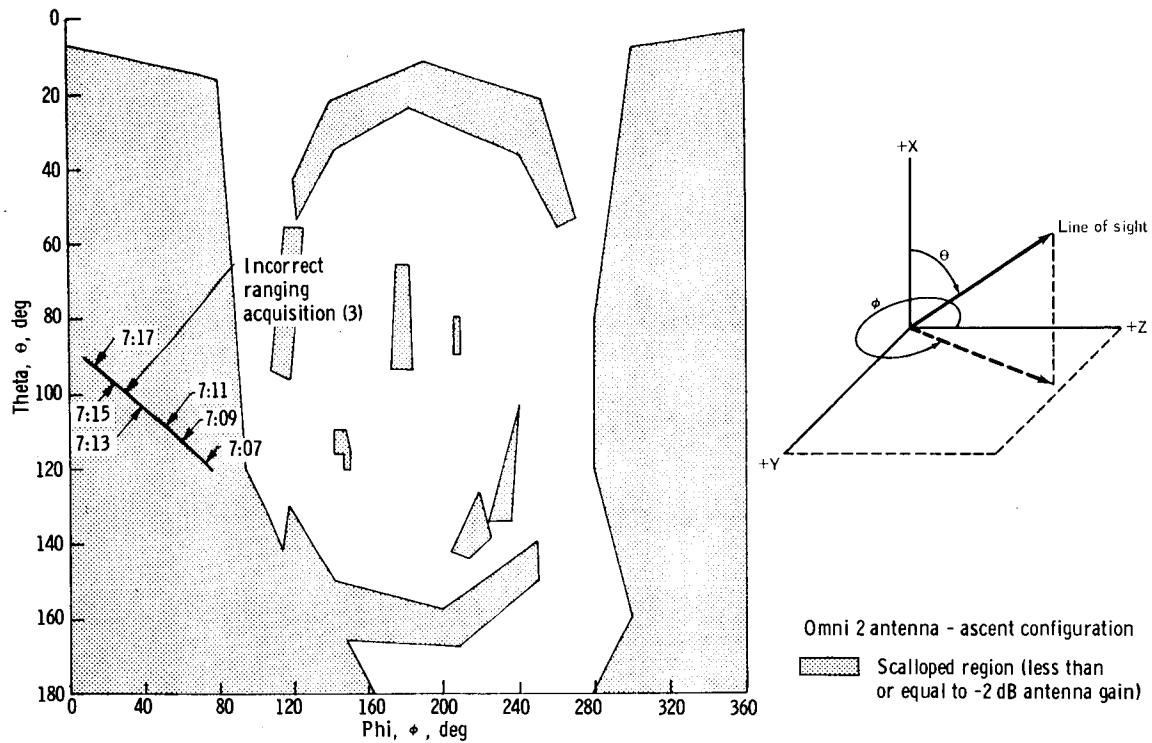
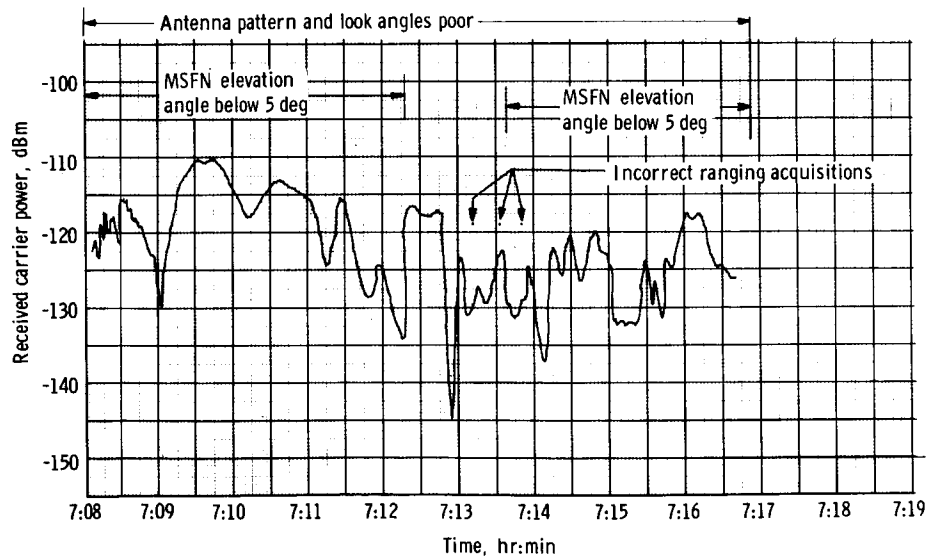
Figure 4. - Received S-band downlink carrier power and look angles, Carnarvon, revolution 5.

Carnarvon	5	7:13:10	4	Incorrect acquisition attributed to low signal level. The spacecraft-to-site look angle was in the scalloped region of the omni 2 antenna pattern. The omni 1 antenna would have provided approximately 18 dB stronger carrier power.

7:13:34	4	Incorrect acquisition attributed to low signal level. The spacecraft-to-site look angle was in the scalloped region of the omni 2 antenna pattern. The omni 1 antenna would have provided approximately 21 dB stronger carrier power.

7:13:52	4	Incorrect acquisition attributed to low signal level. The spacecraft-to-site look angle was in the scalloped region of the omni 2 antenna pattern. The omni 1 antenna would have provided approximately 25 dB stronger carrier power.

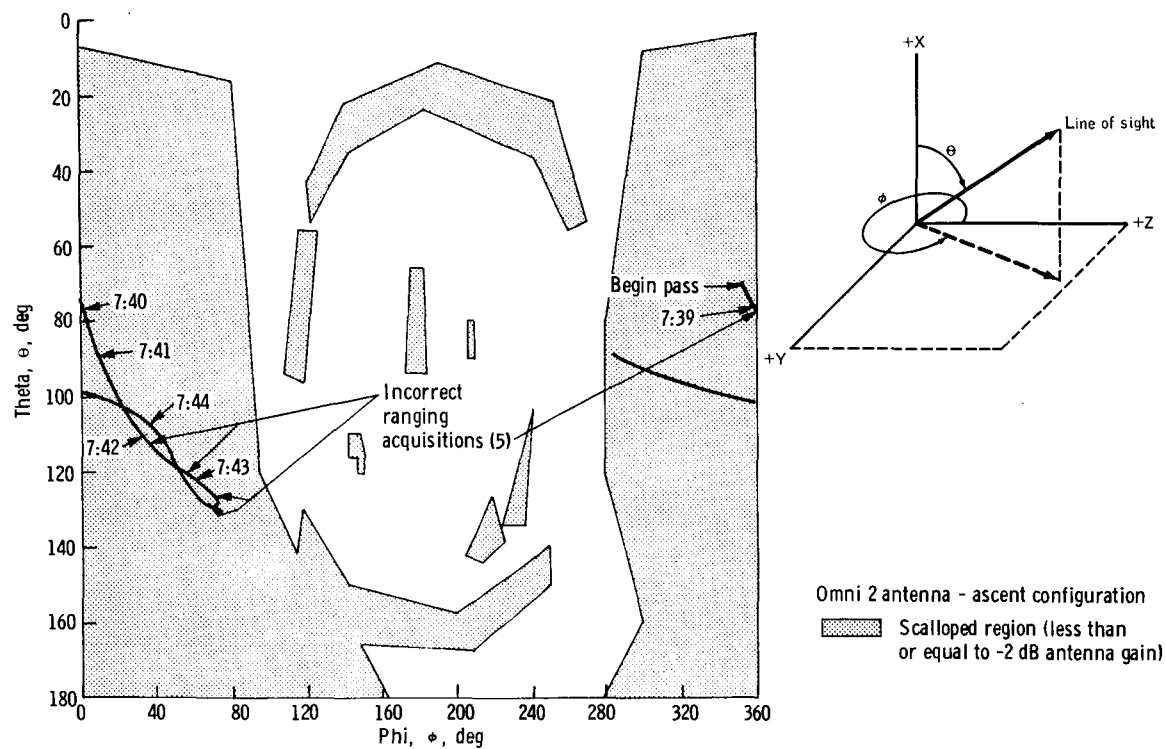
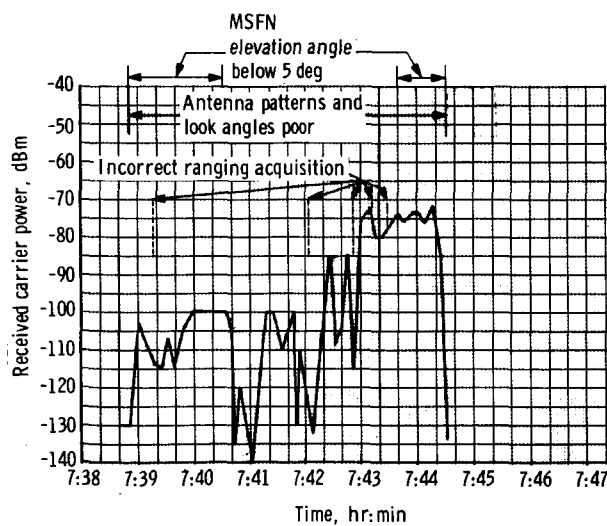
Figure 5. - Received S-band downlink carrier power and look angles, Hawaii, revolution 5.

Station	Revolution	Time, hr:min:sec	Figure number	Comments
Hawaii	5	7:39:16	5	Incorrect acquisition attributed to low signal level caused by sidelobe track. The spacecraft-to-site look angle was in the scalloped region of the omni 2 antenna pattern. The omni 1 antenna would have provided approximately 23 dB stronger carrier power. The site-to-spacecraft elevation angle was approximately 1.6 degrees during this acquisition attempt.

7:42:04	5	Incorrect acquisition attributed to low signal level because of a sidelobe track. The spacecraft-to-site look angle was in the scalloped region of the omni 2 antenna pattern. The omni 1 antenna would have provided approximately 19 dB stronger carrier power.

7:42:52	5	Incorrect acquisition occurred during attempt to gain main beam auto-track. The spacecraft-to-site look angle was in the scalloped region of the omni 2 antenna pattern. The omni 1 antenna would have provided approximately 25 dB stronger carrier power.

7:43:16	5	Incorrect acquisition. The spacecraft-to-site look angle was in the scalloped region of the omni 2 antenna pattern. The omni 1 antenna would have provided approximately 25 dB stronger carrier power.

7:43:28	5	Incorrect acquisition. The spacecraft-to-site look angle was in the scalloped region of the omni 2 antenna pattern. The omni 1 antenna would have provided approximately 26 dB stronger carrier power.
Guam	5	7:26:58	-	Incorrect acquisition. No data available for analysis.

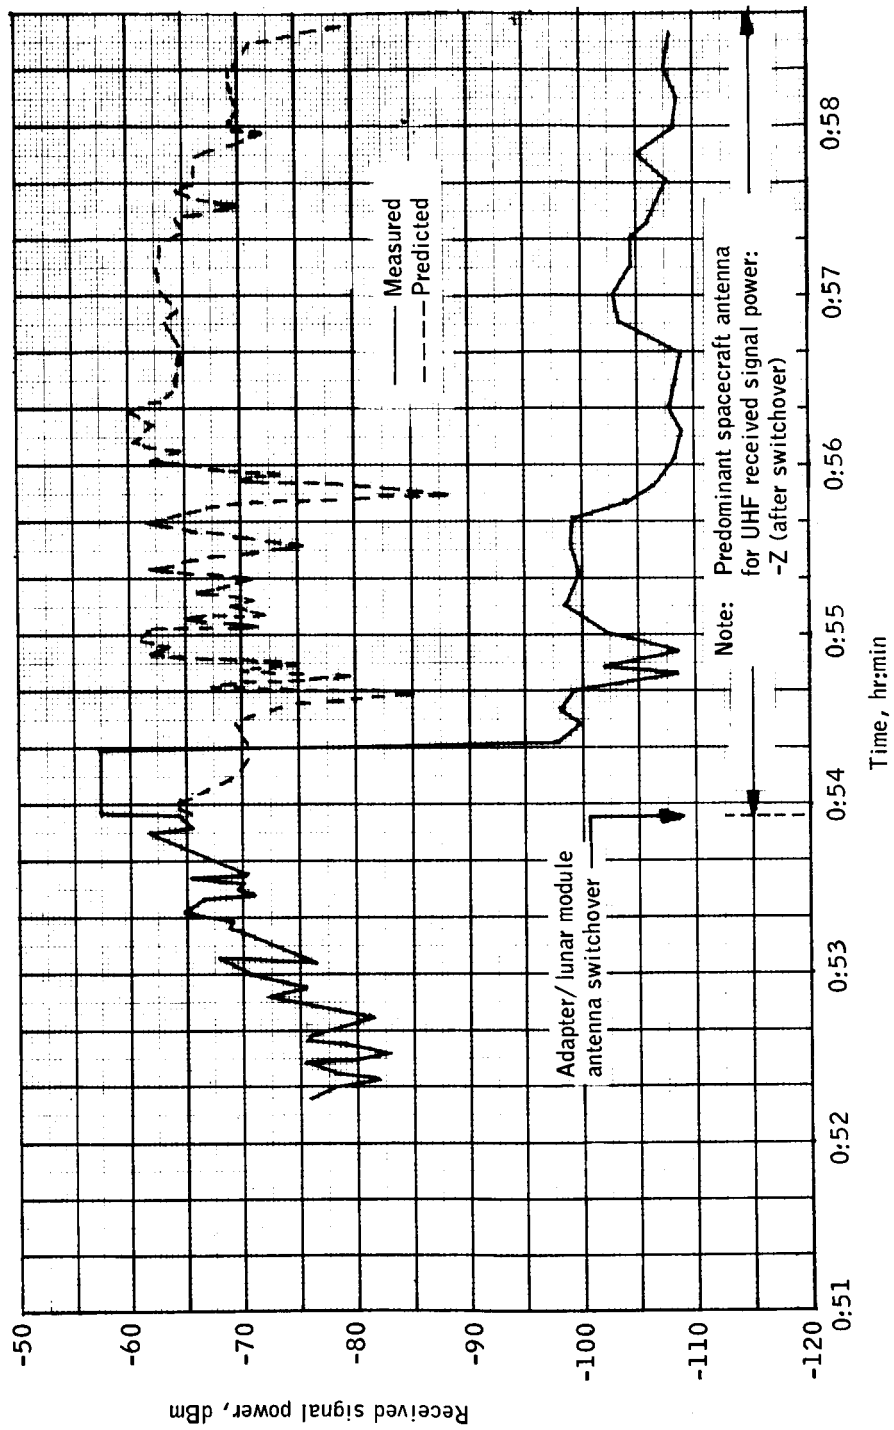
Figure 8.- Total received UHF power, Carnarvon, revolution 1.

The fourth source was the possibility that the best-estimate trajectory and measured spacecraft-to-site look angles would reveal areas of poor antenna coverage coincident with the signal strength fluctuations. This, however, was not the case. For example, figures 8 through 11 show comparisons of measured and predicted received UHF signal strength for passes over the Bermuda, Texas, and Carnarvon stations. These passes are typical and show that the areas of signal degradation could not be predicted and therefore, were not due to the effects of antenna patterns or poor spacecraft-to-site look angles.

Station	Revolution	Figure number	UHF signal strength for 5 to 5 deg elevation	Predominant antenna
Carnarvon	1	8	At adapter/lunar module antenna switchover, the signal strength jumped 6 dB above predictions and then dropped 40 dB abruptly at 0:54:20 and remained 40 dB below predictions for the remainder of the pass.	Minus Z after switchover at 0:53:56
Texas	1	-	Good for entire pass and corresponds with predictions.	Rotated from minus Z to plus Z
Bermuda	2	9	Good for entire pass except for a momentary drop which is in agreement with predictions.	Rotated from minus Z to plus Z
Carnarvon*	2	-	Dropouts prior to 2:25:02 because of low elevation angle. Good for entire pass except for momentary drop at 2:28:19.	Minus Z
Texas	2	10	Low for entire pass. Approximately 40 dB below predictions.	Rotated from minus Z to plus Z
Merritt Island	2/3	-	Low for entire pass.	Information not available
Carnarvon*	3	16	Good until 4:00:02, when abrupt drop 40 dB below predictions. Abrupt rise at 4:02:22; then agreed with predictions. Dropouts prior to 3:59:16 because of low elevation angles.	Minus Z

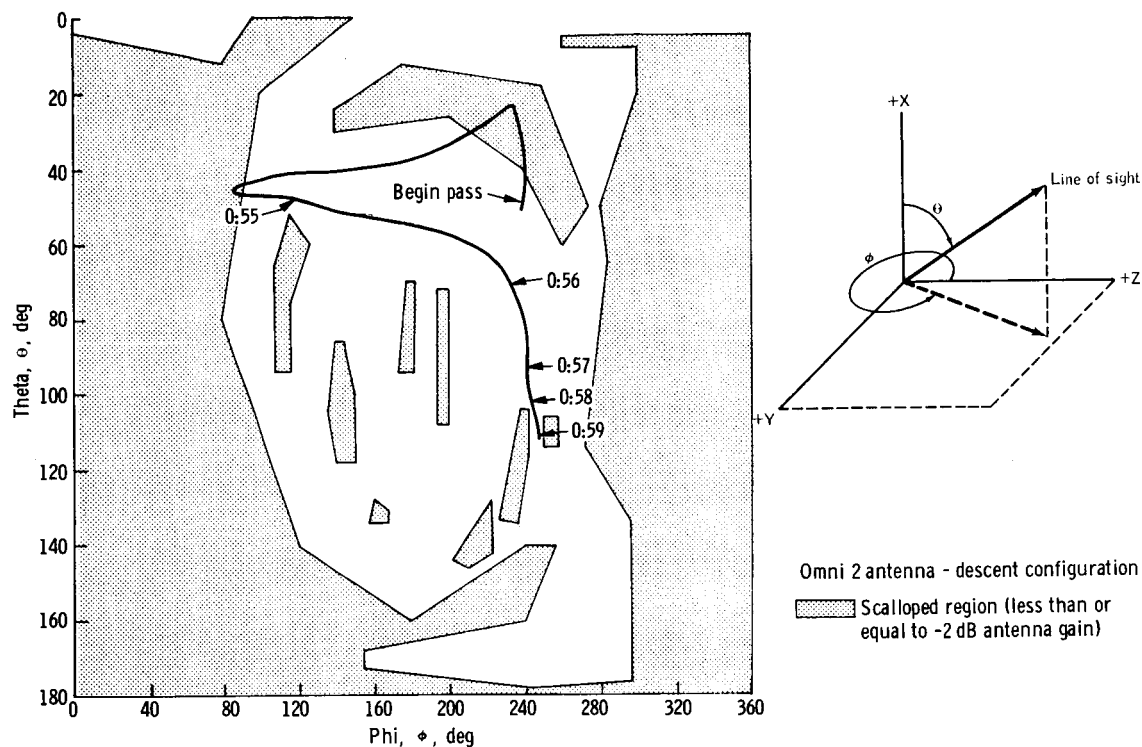
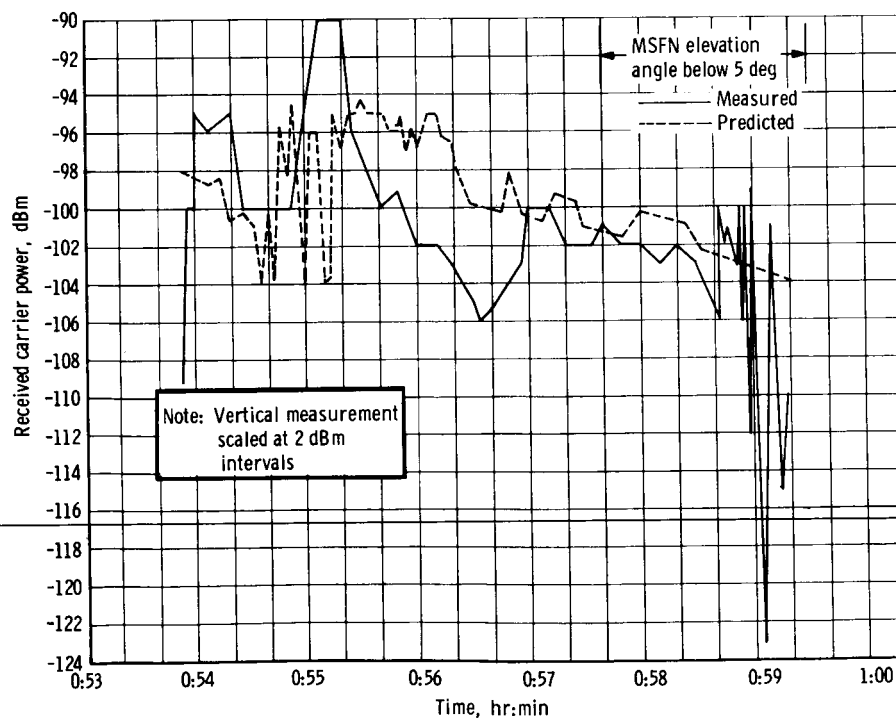
Figure 12. - Received S-band downlink carrier power and look angles, Carnarvon, revolution 1.

Station	Revolution	Figure number	Comments
Carnarvon	1	12	Measured and predicted carrier powers agree very closely for the entire station pass. The spacecraft-to-site look angles remained in the favorable region of the active omnidirectional antenna.
Texas	1	13	Periods of both good and poor correlation between predicted and measured received carrier power levels can be seen. Except for dropouts during switchover to the power amplifier (approximately 1:33), the measured carrier power followed predictions fairly well until 1:35, when the look angle entered the scalloped region at a theta of 296 degrees. For the next several minutes, the comparison ranged from poor to fair again, as the look angle passed across the scalloped region.
Carnarvon	3	14	The trend of the measured and predicted carrier power showed fair correlation except for a few scattered time intervals. It can be seen that the spacecraft-to-site look angle entered the heavily scalloped portion of the antenna pattern shortly before 4:03, where it remained for the rest of the pass.

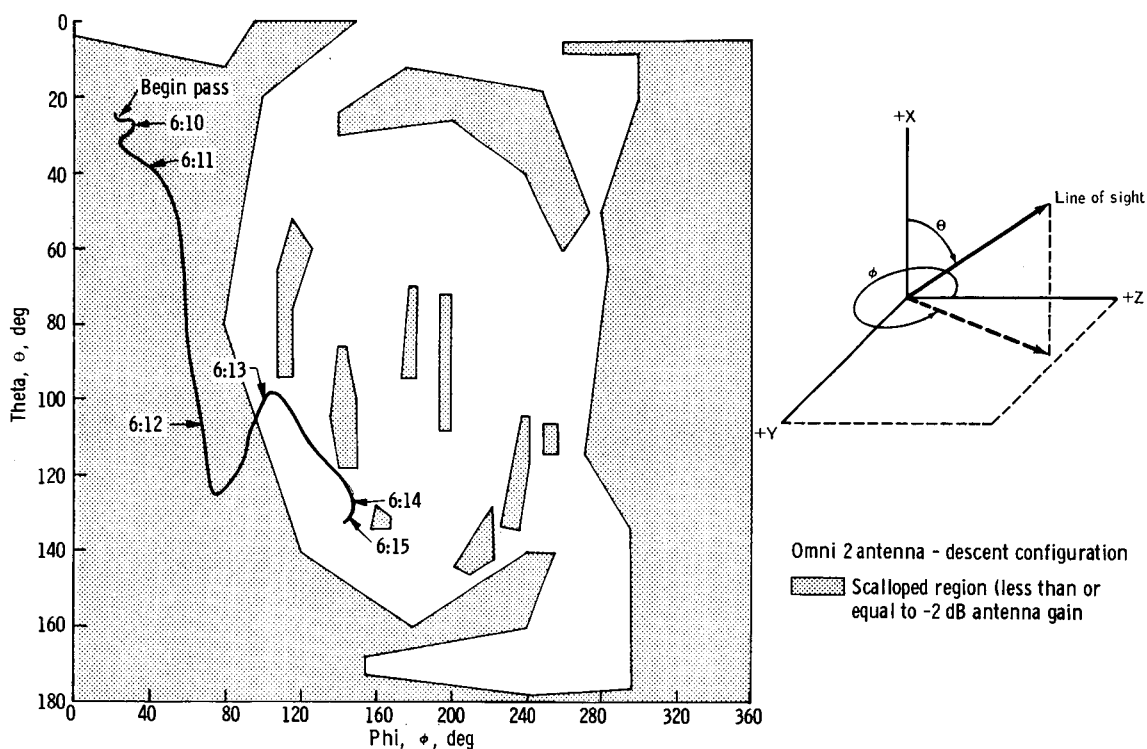
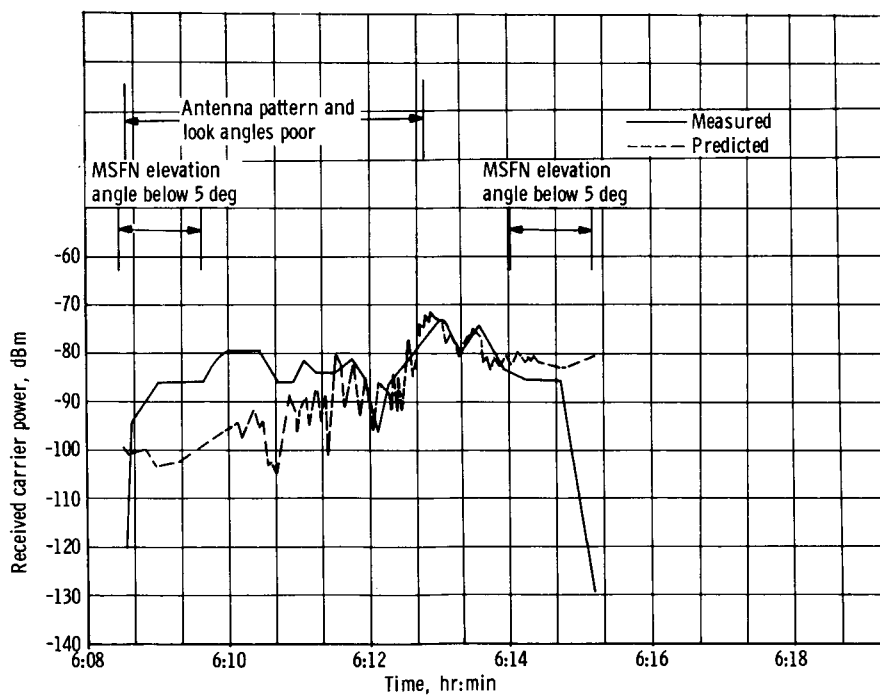
Figure 15. - Received S-band downlink carrier power and look angles, Guaymas, revolution 4.

Guaymas	4	15	Measured and predicted carrier powers agreed very closely during the last third of the station pass. For the first two-thirds of the pass, the spacecraft-to-site look angles were in the unfavorable region of the antenna pattern, which resulted in poor correlation between predicted and measured data.
Texas	4	16	Good correlation between measured and predicted received carrier power existed except for approximately 2-1/2 minutes, during which the line-of-sight between the ground station and the spacecraft was in the site antenna keyhole and the site antenna was tracking on a sidelobe. The spacecraft look angles remained in the favorable region of the antenna pattern during this pass.

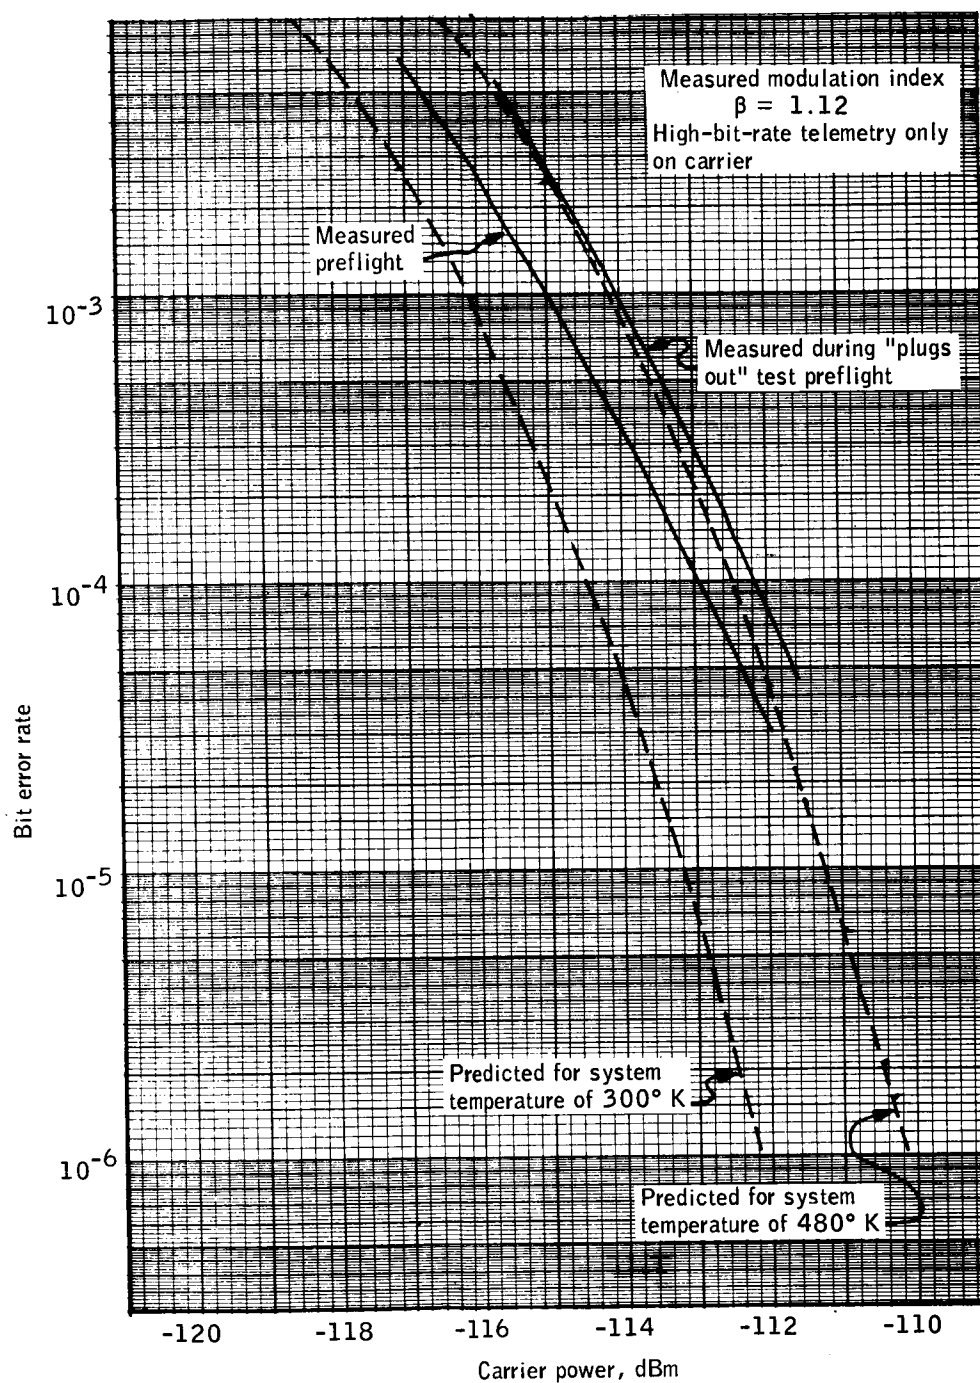
Figure 17.- Bit error rate versus recieved carrier power, primary transponder.

Prior to the launch of Apollo 5, bit-error-rate tests were conducted at Kennedy Space Center primarily to determine whether incidental phase modulation existed within the spacecraft. No such modulation was found; however, during the test, the measured bit error rates (as compared with received carrier power) were discovered to be 1 to 2 dB lower than had been predicted.

Reevaluation of the prediction calculations revealed two faulty areas: antenna temperature and circuit loss ratio. The original prediction of antenna temperature assumed a 5-degree antenna elevation angle at the Merritt Island Site, resulting in an antenna temperature of 90° K. For this test, however, a zero degree elevation angle with a 150° K antenna temperature was determined to be more realistic.

Also, the original prediction assumed a 0.5 dB circuit loss between the antenna and preamplifier at Merritt Island. This test, however, required additional attenuation.

The combined effect of the additional attenuation and the updated antenna noise temperature resulted in an increase in the system noise temperature from 300° K to 480° K. A 2 dB increase in system noise that caused a shift in the predicted bit error rate curve resulted in much better correlation with the measured bit error rate curve. Figure 17 shows the measured and predicted bit error rates for the primary transponder with a measured modulation index of 1.12 radians. Figure 18 shows both measured and predicted bit error rates for the secondary transponder with a measured modulation index of 1.03 radians. These two figures show that the predictions based on the higher system noise temperature of 480° K agree well with the measured results.

In conclusion, the discrepancy between the measured and predicted prelaunch bit error rates was probably caused by an oversight in calculation of the system noise temperature.
